# DID YOU KNOW?

## ADVICE FOR THE PROFESSIONAL

### Overview

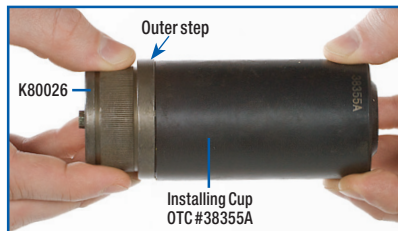
**UPPER BALL JOINT - CORRECT**

Correct fit, against outer step

These ball joints press in and apply force on the stud end of these applications. It is important that the installation cup be placed on the outer step of the ball joint housing. Pressing in the ball joint with force against the inside lip may push the lip and lower bearing into the stud, causing binding and premature failure. Always press in these ball joints using the outer step.

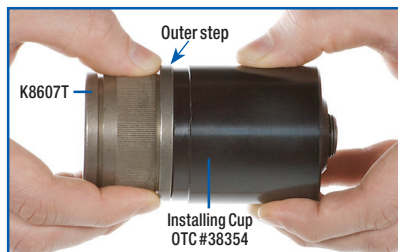
**LOWER BALL JOINT - CORRECT**

Correct fit, against outer step

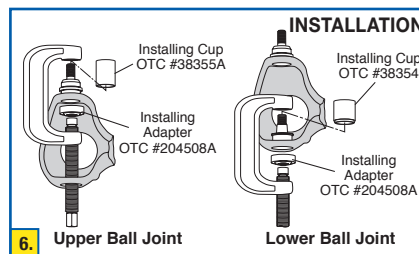
6. Upper Ball Joint

Incorrect fit, not against outer step

1. Clean the knuckle ball joint mating surfaces thoroughly.
2. Apply a suitable lubricant to the ball joint mating surface and assemble the ball joint into the knuckle.
3. Assemble the ball joint press components as shown in Fig 6. Check the alignment of all components. Tighten the forcing screw until the ball joint is firmly seated.
4. Install the snap ring on the upper ball joint.
5. Repeat Steps 1-3 to install the lower ball joint. Install the snap ring.
6. Install the knuckle assembly to the vehicle according to the vehicle service manual procedures.
