# DID YOU KNOW?

## ADVICE FOR THE PROFESSIONAL

### Overview

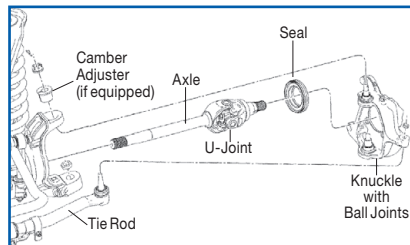
Remove the wheel hub, bearing and axle.

With the axle out, inspect the u-joint. If the u-joint is in poor shape it should be replaced. Failed u-joints can cause noise and binding, and are easily replaced at this point. We recommend replacing with MOOG premium u-joint 374.

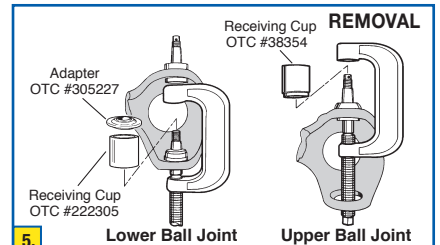
Now remove the ball joints from the knuckle. It is easier to remove the **lower** ball joint first. First, remove the snap ring, then use a ball joint press and appropriate receiving cups and adapters.

Then remove the **upper** ball joint from the knuckle, utilizing a ball joint press and appropriate receiving cups and adapters. (FIG 5)
